## CASE STUDY

# Global, Comprehensive Materials, Corrosion & Integrity Support

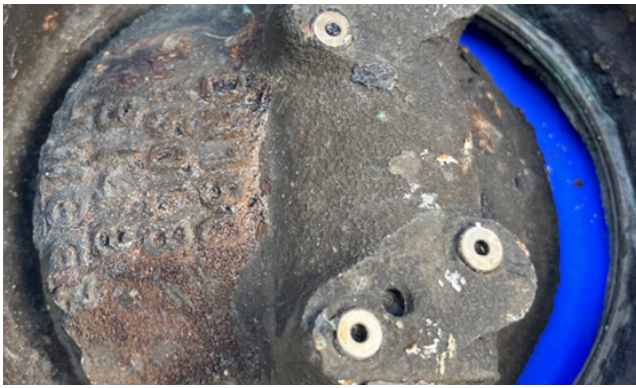
Degraded Butterfly Valve Sent in for Failure Analysis

When several butterfly valves in the seawater injection system failed, Viking worked with facilities engineers, production chemists, and our own Laboratory Services to conduct a failure analysis that revealed multiple degradation mechanisms.

Along with metallurgical analysis, Viking was able to suggest process controls to minimize future corrosion risk. We also recommended materials for procuring replacement valves that would hold up. Participation at multiple levels from production chemistry to integrity management allowed Viking to address a complex issue from multiple angles.

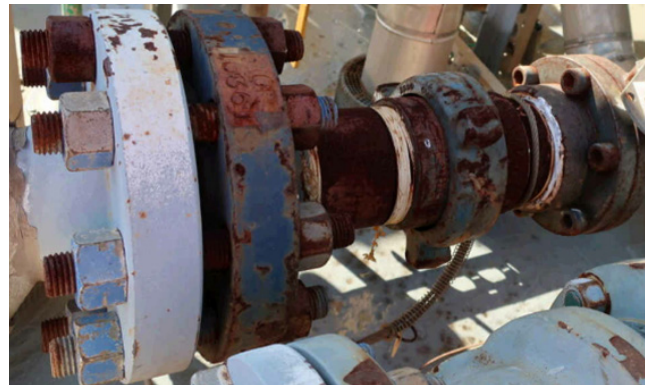
Rapid Atmospheric Corrosion on an Offshore GOM Piping Spool

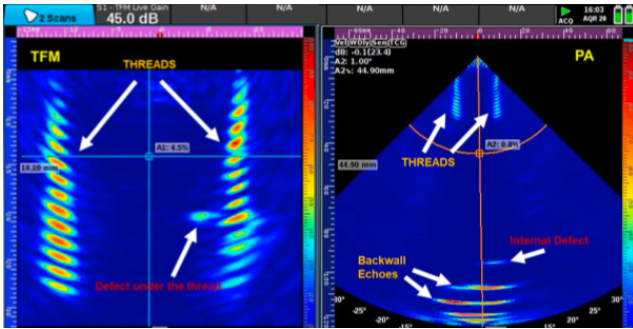
Display Images for Total Focusing Method (TFM) and Phased Array Ultrasonic Testing (PAUT)

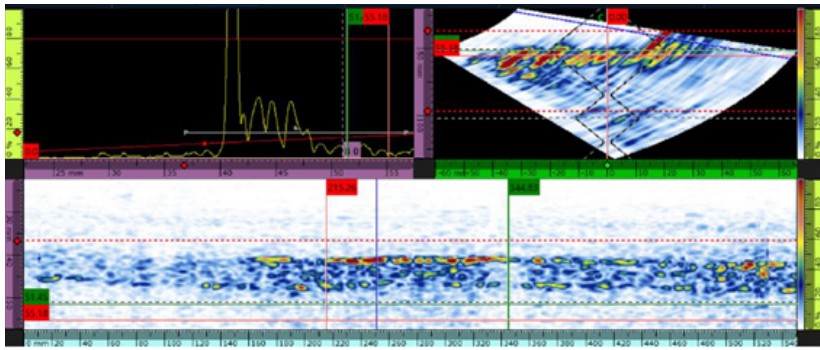
**PAUT Scan of Crack Through Vessel Cladding**

Here's the background: The client had a vessel fabricated from standard carbon steel clad with a 3 mm thick layer of type 316 stainless steel. The plate of the vessel walls was explosion-clad and the nozzle connections were weld-clad. On a routine internal inspection (visual and dye-penetrant) after a few years of service, the inspectors found several indications that looked like defects or even cracks in the welds.

We modeled the crack as a V-shaped opening progressing through the material at the tip. We made some basic assumptions about how the fluids could flow through the crack and estimated the corrosion rate using conventional CO<sub>2</sub> corrosion models. Because the gas processed in this vessel was water-saturated and contained CO<sub>2</sub>, the operator was concerned that

CO<sub>2</sub> corrosion could begin if the cracks in the cladding penetrated through to the base metal. We assembled a geometrical simulation of the deepest observed defects and combined that with a structural analysis that demonstrated the conditions under which the crack could progress and expose the base metal to the process fluids.

Working with the asset team, we developed an operation and inspection plan that added heat tracing to keep the process fluids above the dewpoint (prevent corrosive water from condensing) and predicted how long the vessels could be in service before the risk of an LOPC increased to an unacceptable level. The client was able to continue to safely operate the vessel and avoid downtime until repairs could be completed.
